Revised Final Jurisdictional
Wetland Delineation Report
Redlands Passenger Rail Project
Redlands, San Bernardino County, California

July 2013

Revised Final Jurisdictional Wetland Delineation Report Redlands Passenger Rail Project

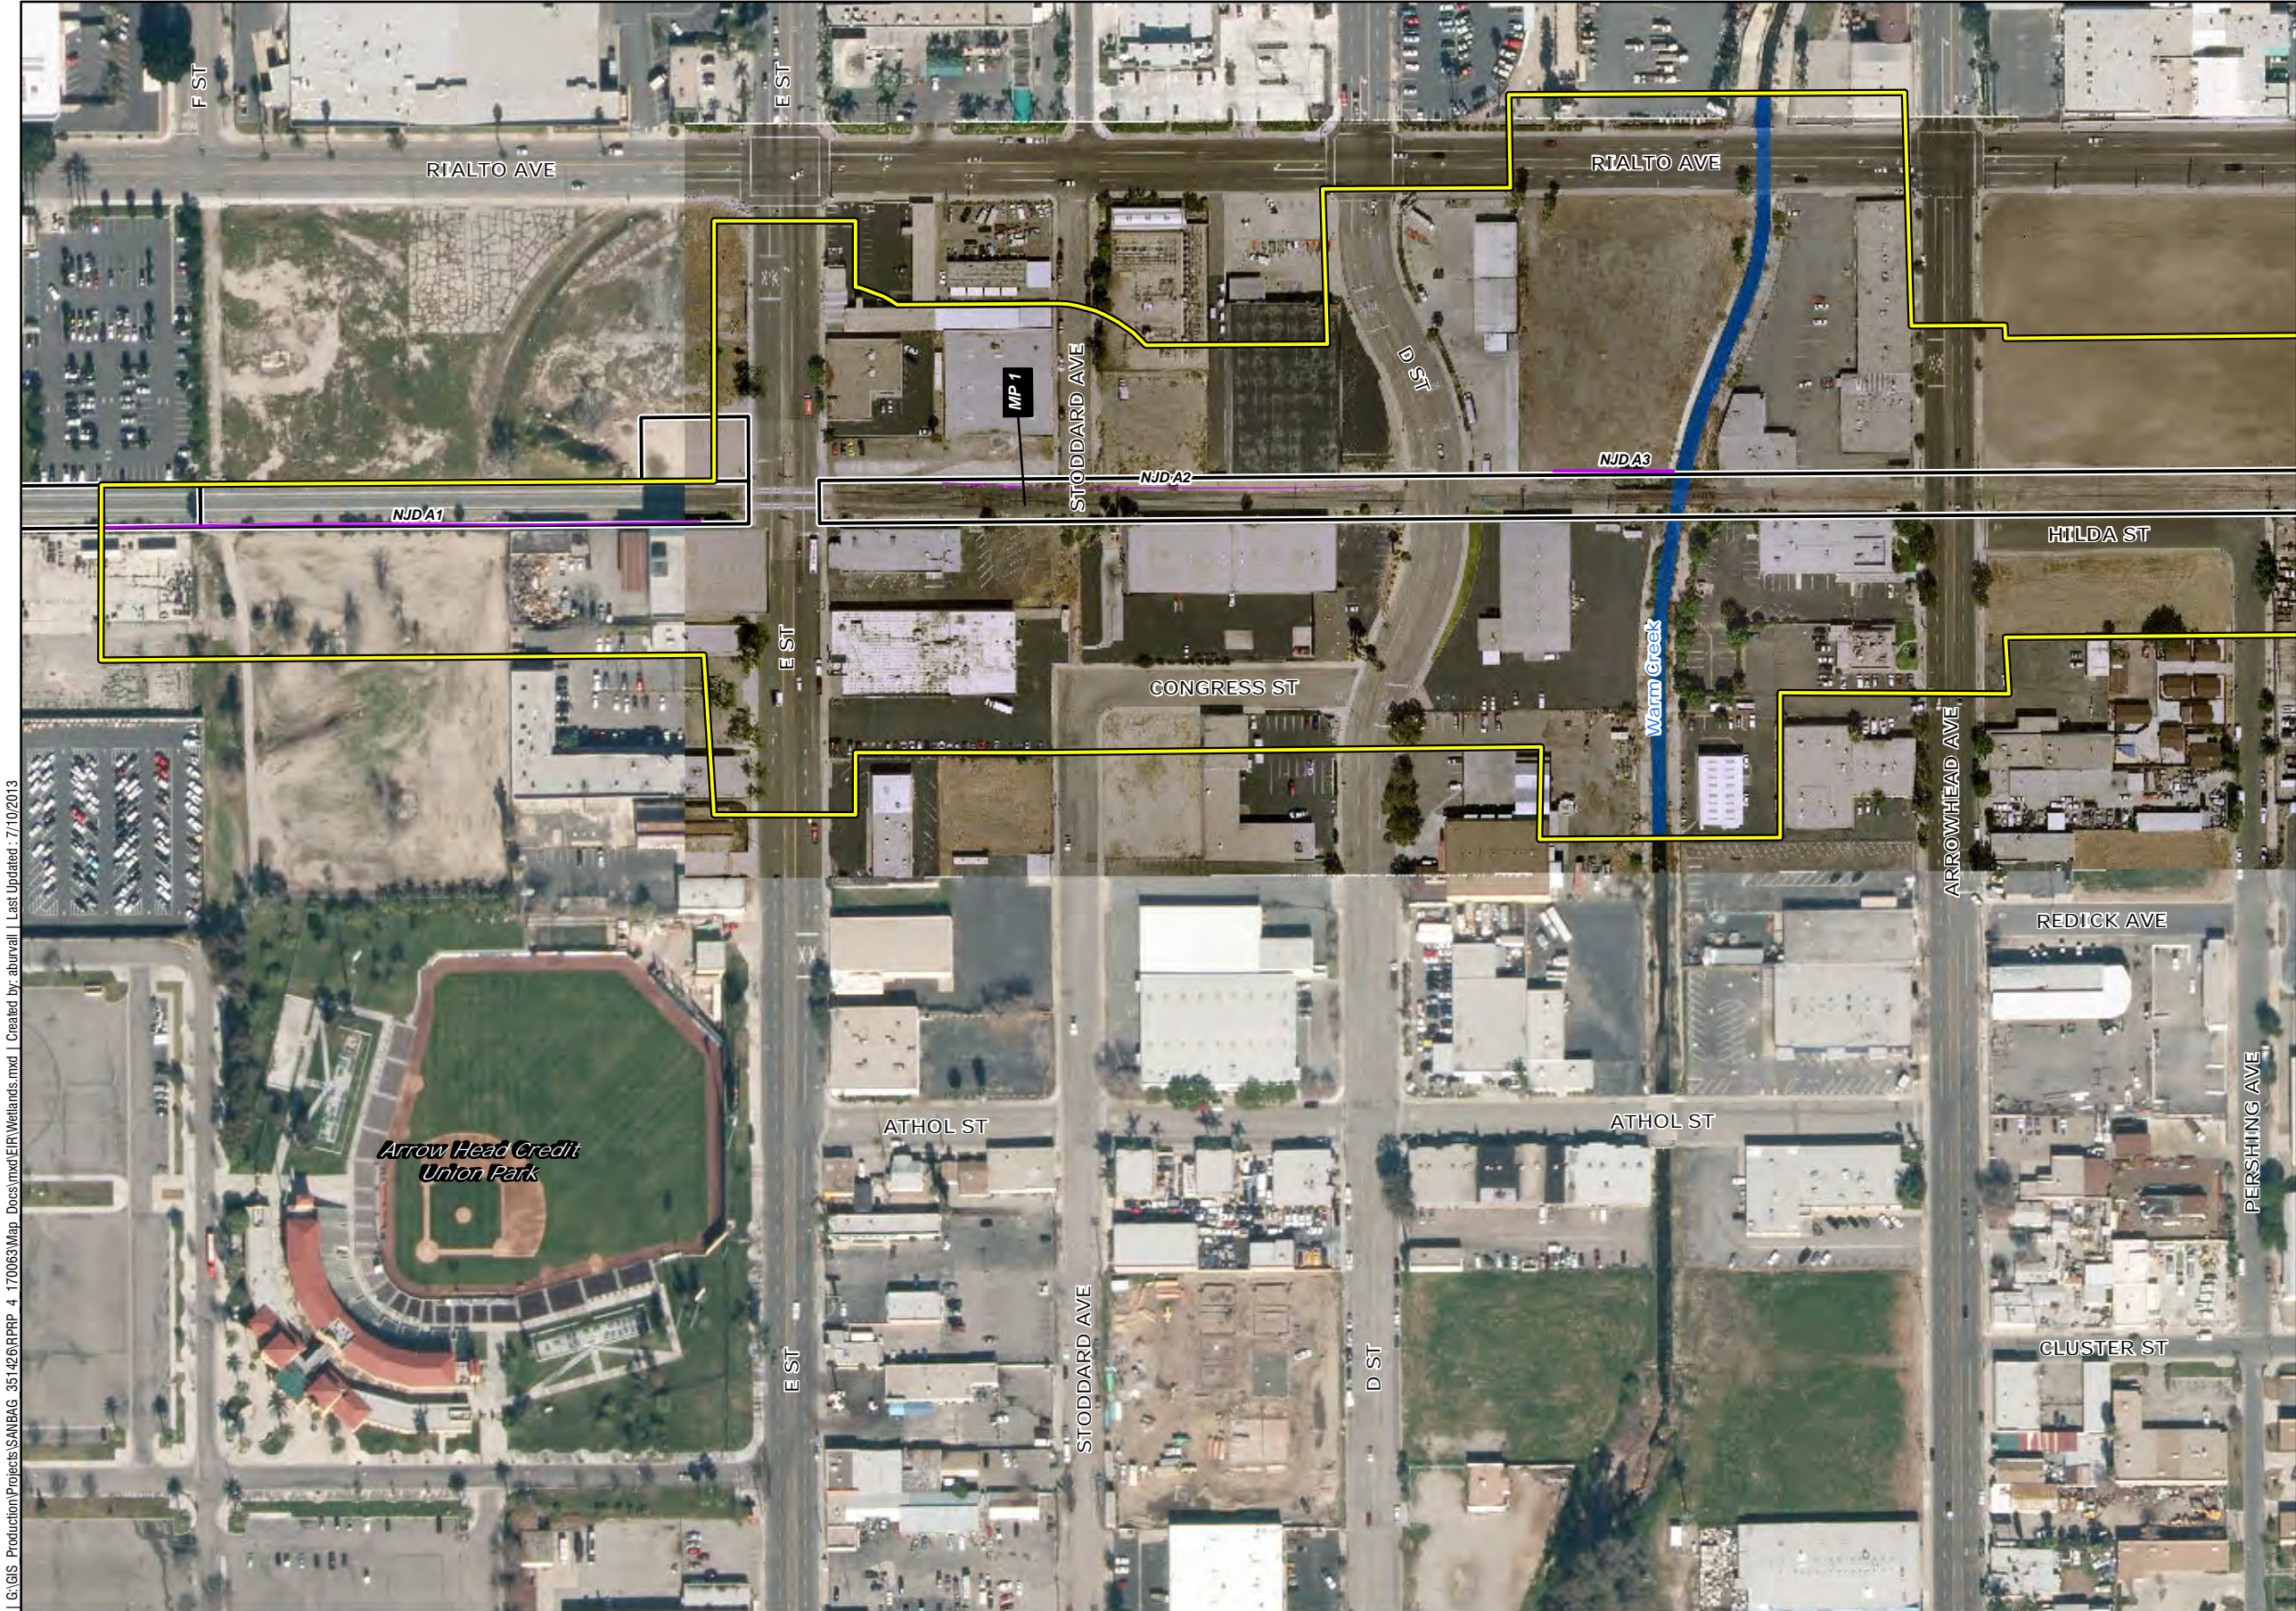
Figure 5 A

- RPRP Study Area
- Railroad ROW
- Jurisdiction**
- CDFW
- USACE Waters of the U.S
- USACE Wetlands
- Non Jurisdictional Ditch
- Soil Pit

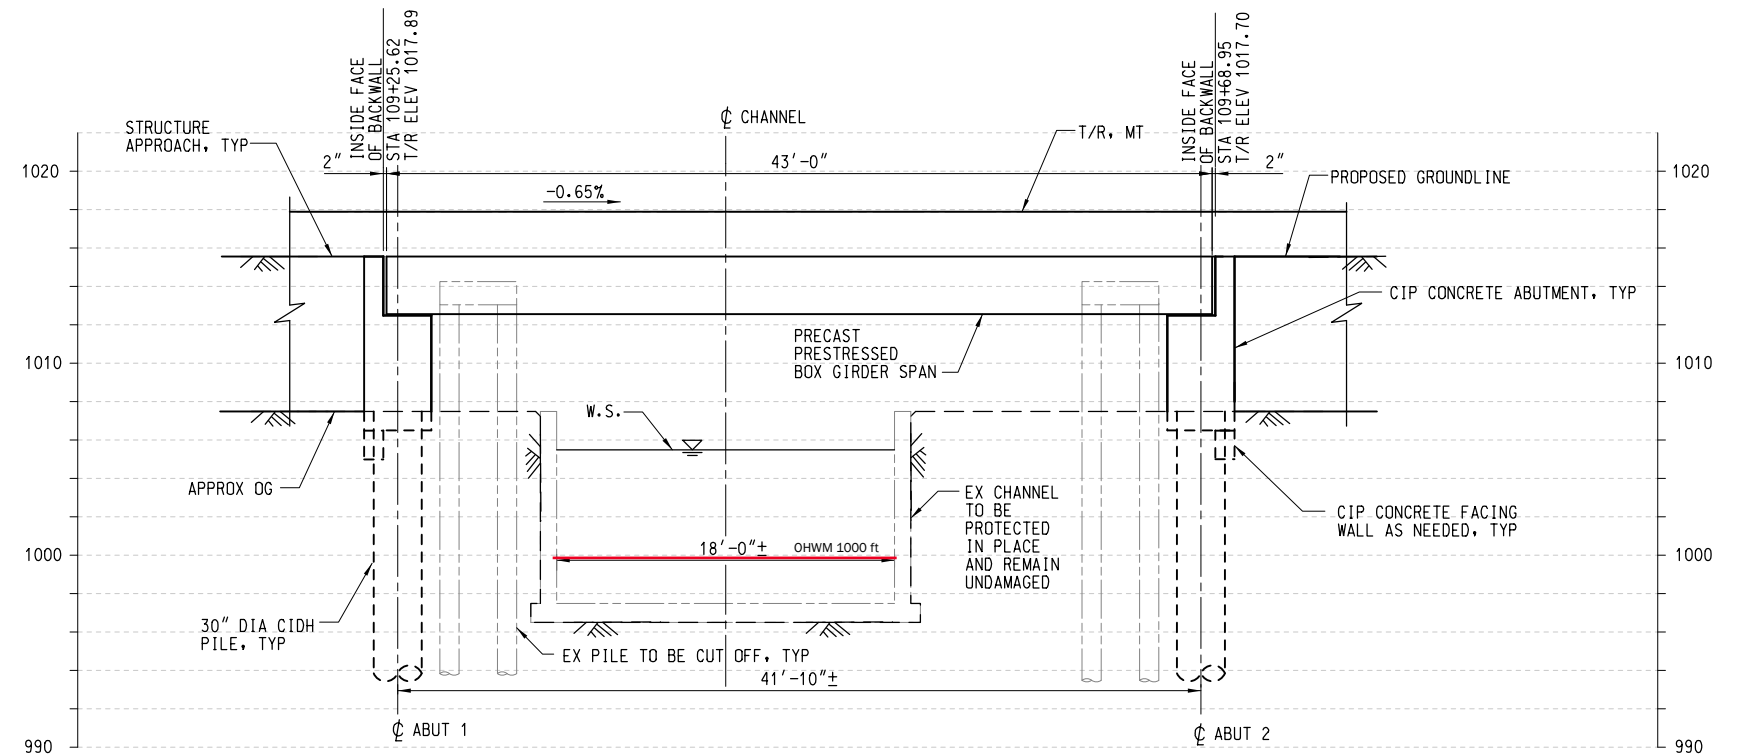
BRIDGE 1.1 - ELEVATION

Exhibit D3. Channel Cross-Sections and OHWM

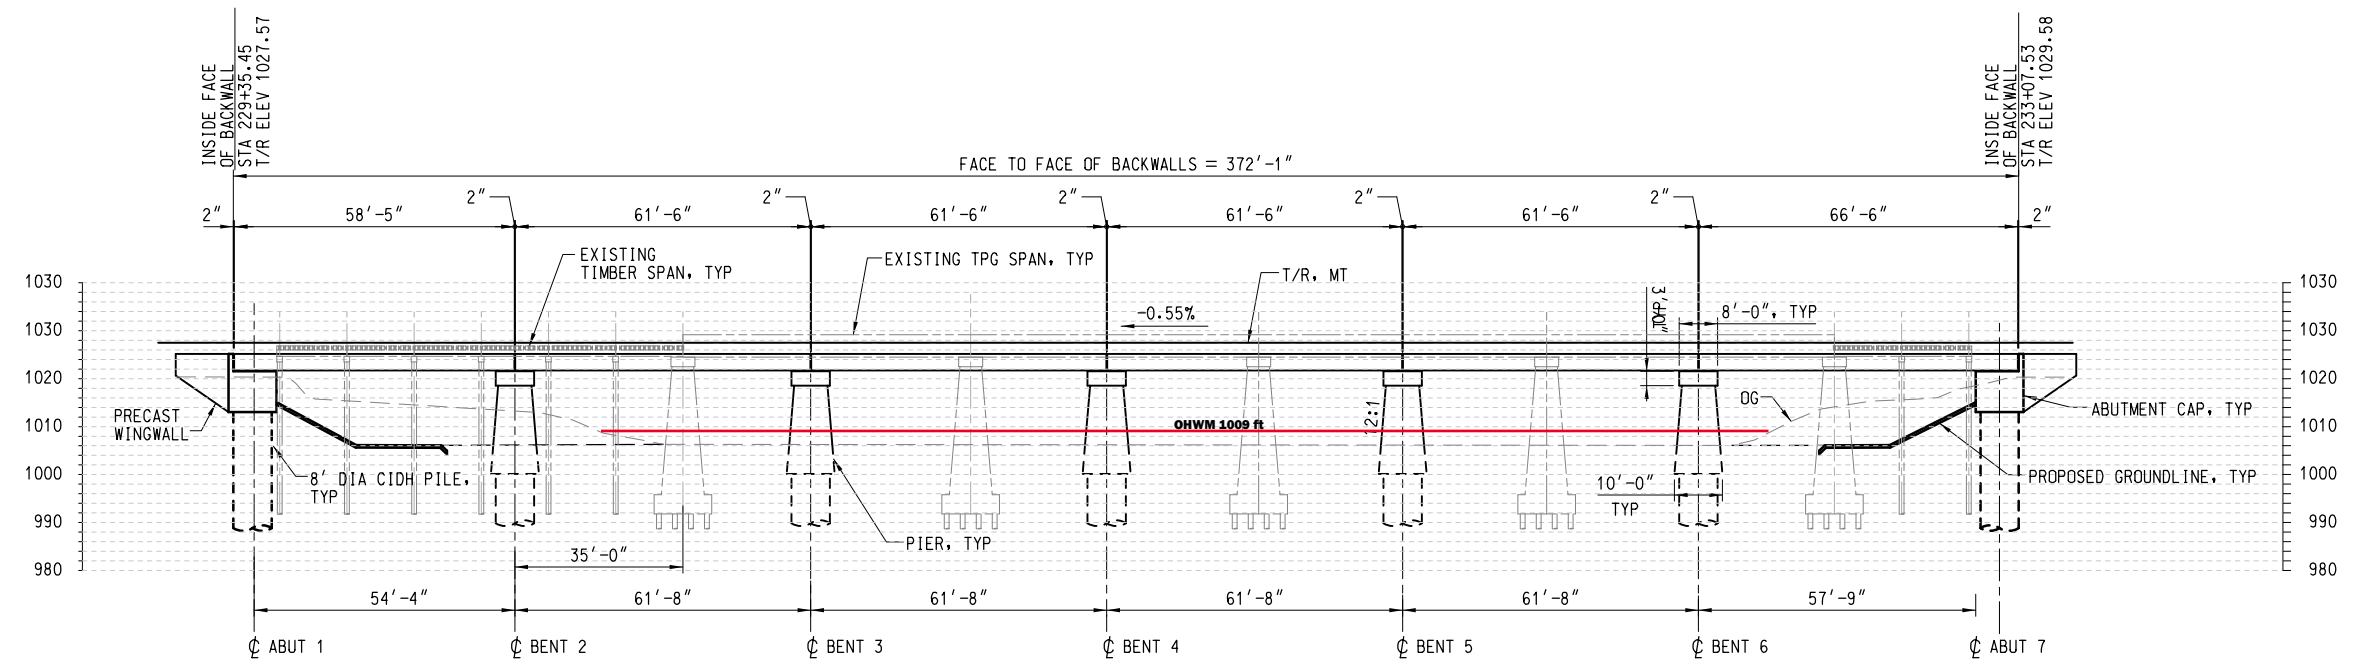
BRIDGE 3.4 ELEVATION

Santa Ana River

The portion of the Santa Ana River within the survey area supports an ephemeral flow regime. Pondered water was observed in the low points of the riverbed up to several weeks after winter and spring rains. However, during various biological surveys, the riverbed was generally observed to be dry. Within the survey area, the Santa Ana River supports waters of the U.S. and CDFW riparian and unvegetated streambed.
